**GULFCO MARINE MAINTENANCE SUPERFUND SITE
INSPECTION, MARCH 9, 2010**

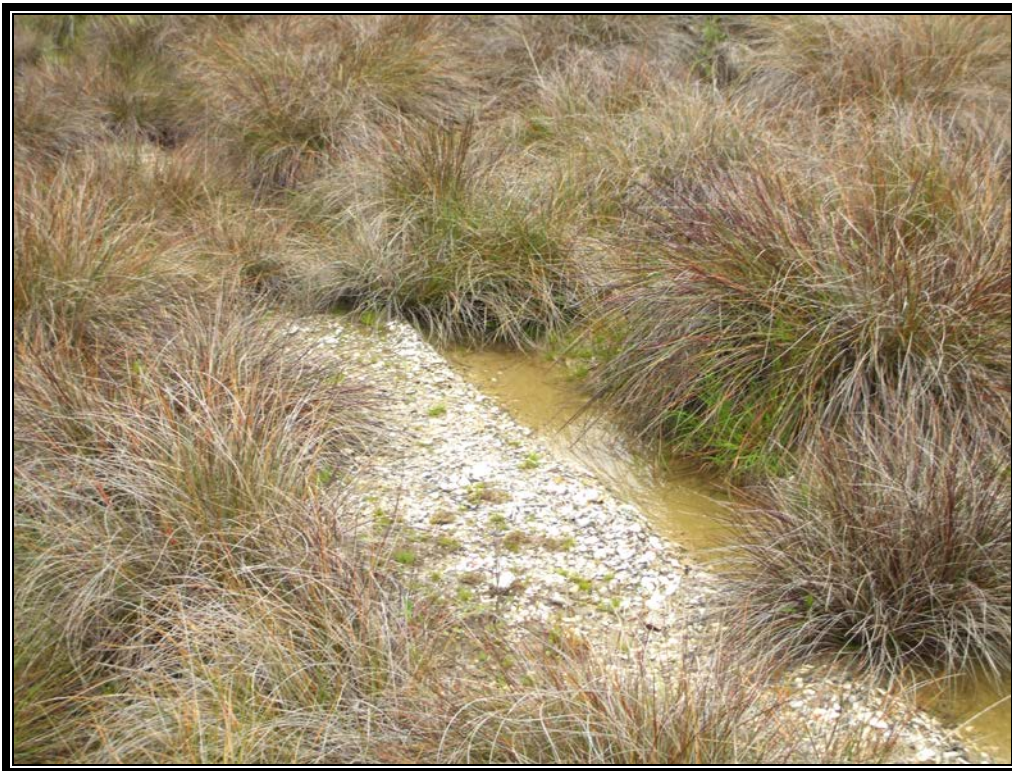
Former Impoundment Cap: rut on top of west side of cap
